T.B. Penick & Sons, Inc. Newsletter Driven by Innovation Since 1905

Featured Project:
UCSD Student Services

UCSD Student Services

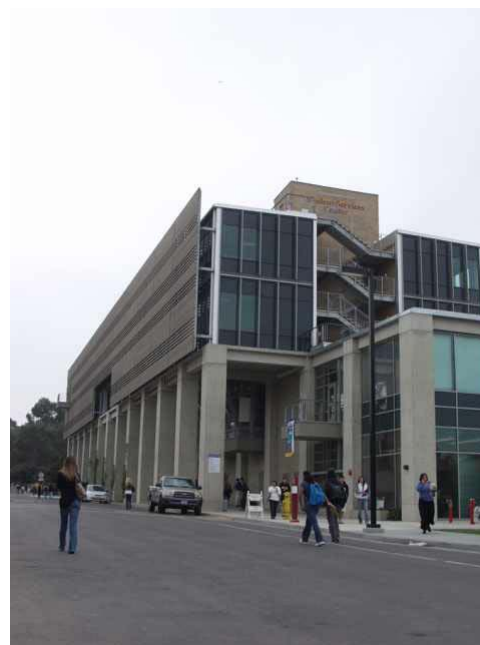
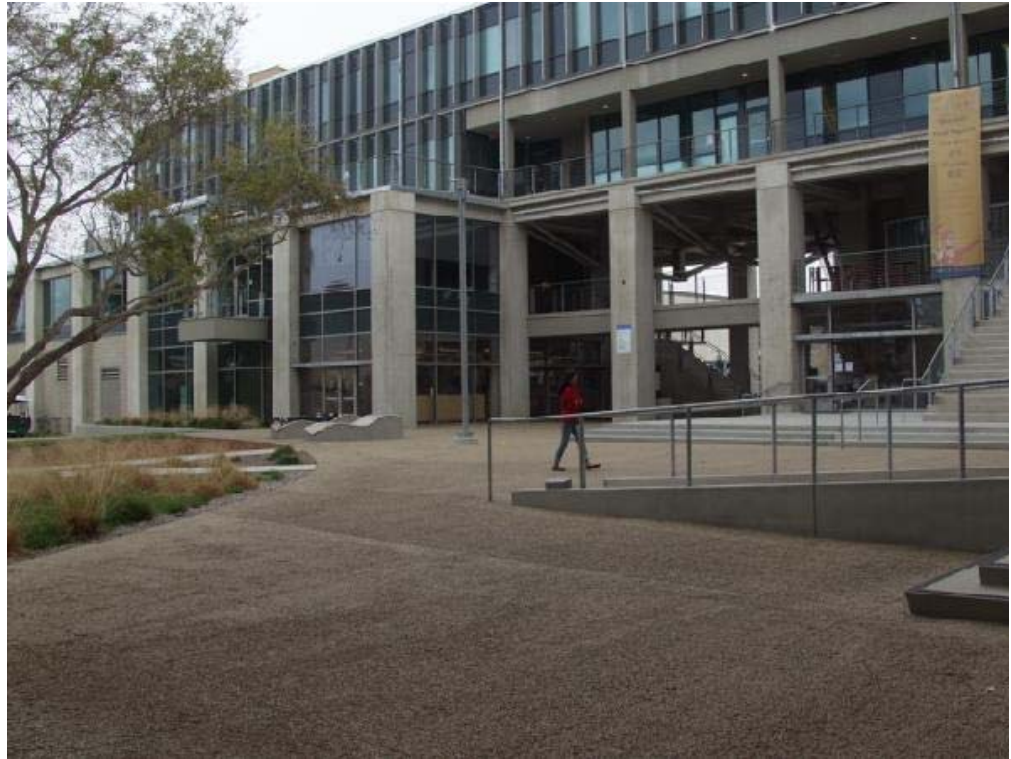
The new UCSD Student Services Center, designed by Rob Quigley Architects, and landscape design by WRT Design gathers existing UCSD student services into one central location. Located next to the Student Union at the heart of the campus, the building is intended to enhance, define, and connect the three major campus quads adjacent to the site. Quigley's design utilizes continuous outdoor loggias and an STF Porous Concrete ground floor plan to encourage campus cross-circulation and help shape the adjacent quads and courtyards. The first floor of 9,500 square feet of integrally colored open-air porous concrete plaza and walkways allows students to pass through and under the L-shaped building.

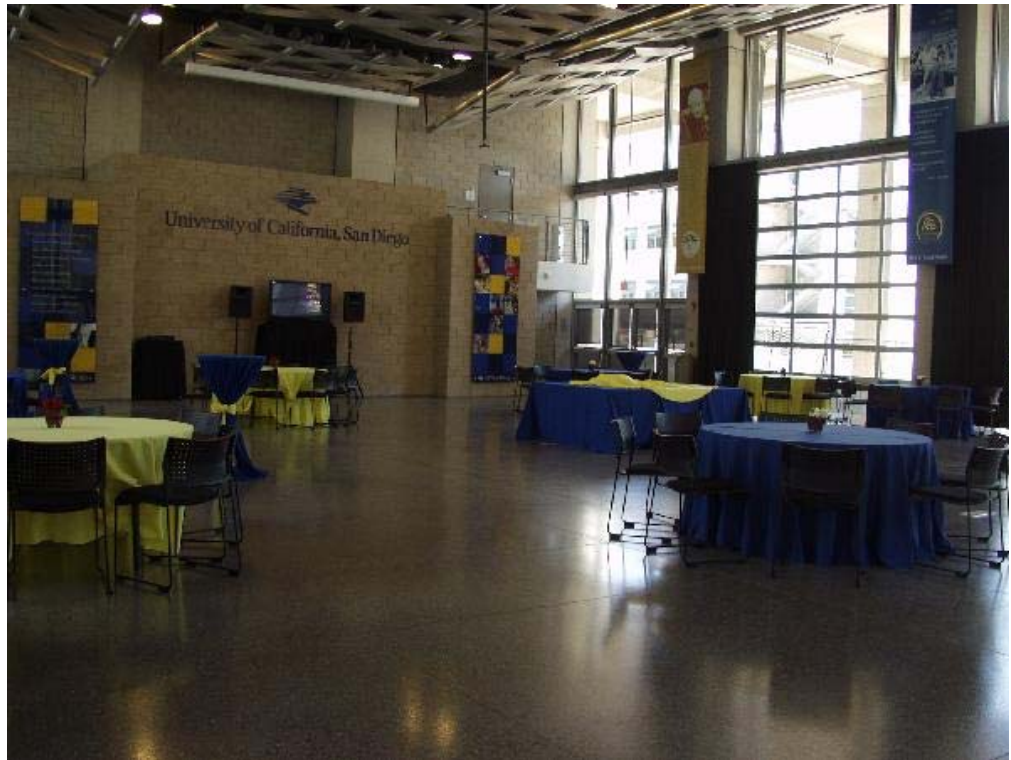
Another green feature of the project is the HD concrete flooring featured in its "Multipurpose Room." The highly reflective floor adds to the brightness of natural light through the large tall windows of the building, minimizing light energy consumption. Polishing the existing concrete also provides value in that it eliminates the need to bring in a secondary floor covering, thereby saving time, reducing expense, and defraying total resource usage. Highly energy efficient and sustainable, concrete is a key construction material for those striving to build green. The usage of concrete reduces energy consumption by reflecting sunlight and utilizing thermal mass for natural heating and cooling.

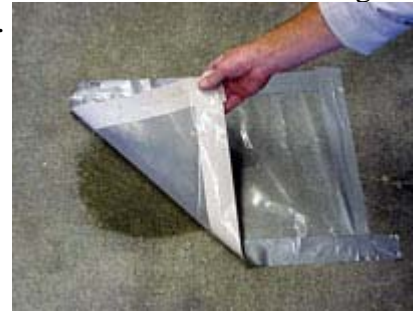
With the growing need to resurface existing concrete floors for commercial and retail environments, the moisture condition of these floors is becoming an important issue for concrete overlay installers. Often times these floors will receive an acid stain treatment or a smooth or textured overlay. Care must be taken when choosing the proper sealer or protective coating, as certain types of coatings result in moisture sensitivity similar to that of some resilient floor coverings. Typical acceptable moisture conditions for those types of applications are 3-5 lbs. per 1000 sq. ft. MVER (moisture vapor emissions rate, ASTM F1869) or less than 75% relative humidity (ASTM F2170). When moisture testing is overlooked, problems may result and expensive repairs may become necessary.

Excessive floor moisture can cause problems with decorative concrete that include the following:

- Increased efflorescence and discoloration on the surface
- Debonding or delaminating of overlays or coatings
- Whiting or blushing of sealers
- Formation of bubbles or blisters in coating or coverings
